Hampshire Avon Fish Counter

Knapp Mill, February 2026

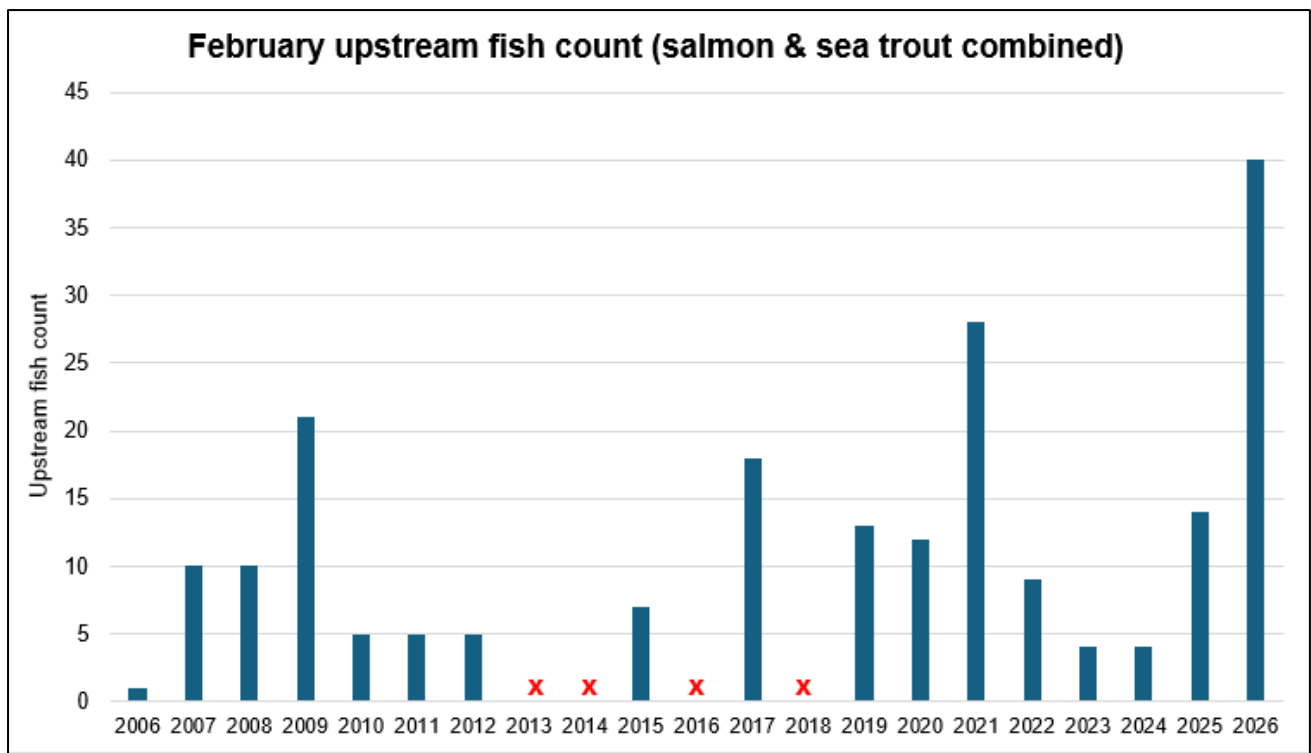
Graph 2 - A comparison of the total upstream fish count in February across each year (excluding 2013, 2014, 2016 and 2018).

This year has seen the highest recorded total in February, with 40 fish heading upstream. This is 386% of the long-term average for this month. Of the fish identified to species level, there was a 2:1 ratio of salmon to sea trout.

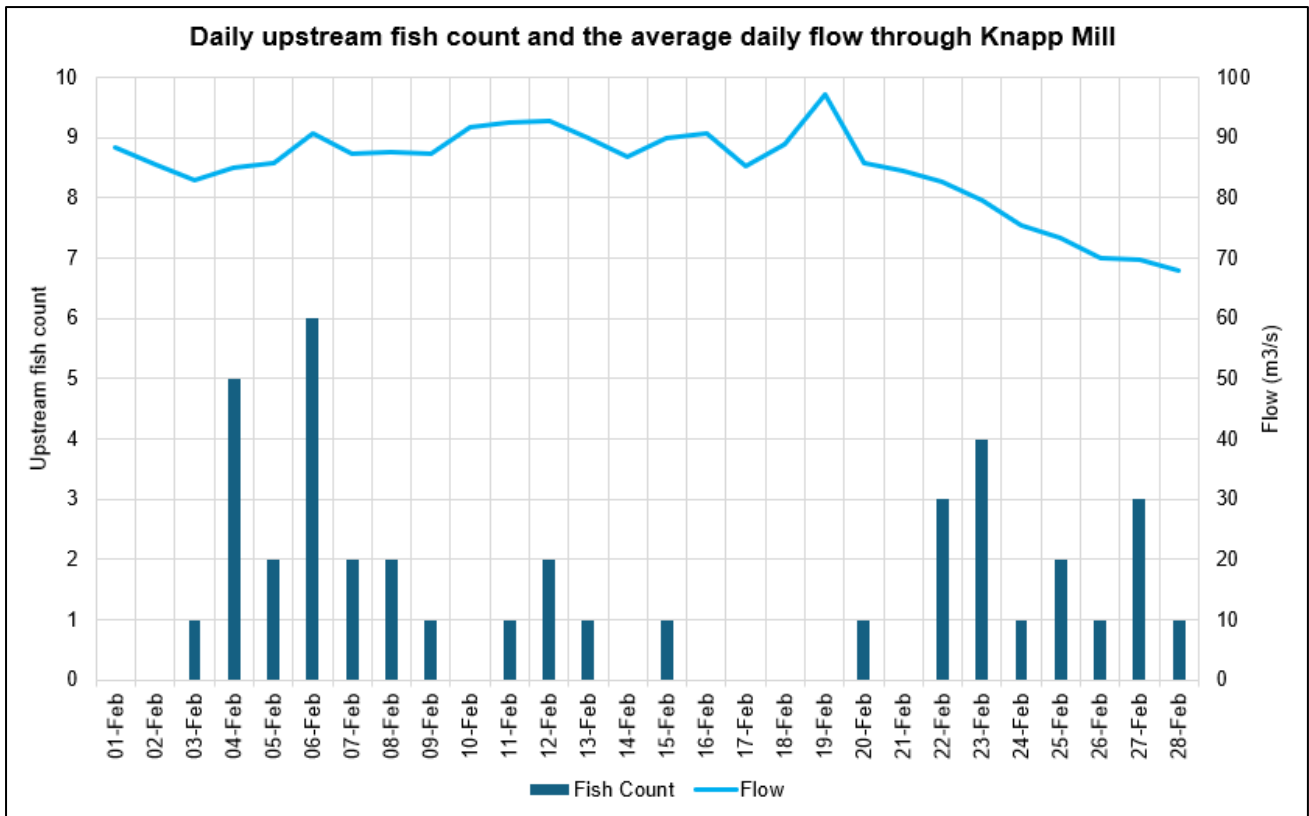
Graph 3 - 2025 upstream fish count each day in February alongside the flow through Knapp Mill for the same period. This data combines both salmon and sea trout.

11 days in February set new highest daily flow records (since 2006), with an average flow for the month similar to that in 2014, and significantly higher than the other years during this period. With the persistent rain, it wasn't until the last week of February that there was any significant reduction in flow at Knapp Mill.

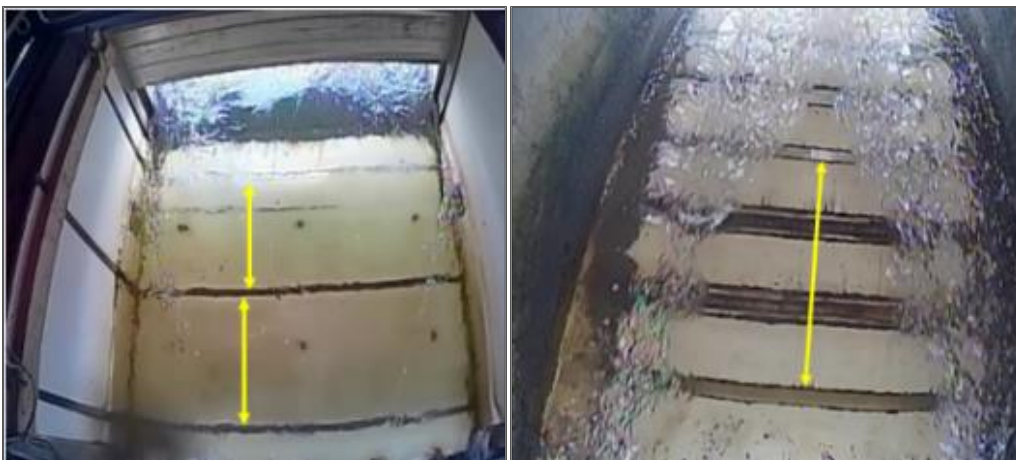
Figure 2 – Overhead view of the Turbine House (left) and Fish Pass (right). The distance between neighbouring electrodes, as indicated by each yellow line, is 45 cm.

Below is a collection of images taken from the counter cameras. Figure 2 offers a sense of scale for any images taken within the fish counters.

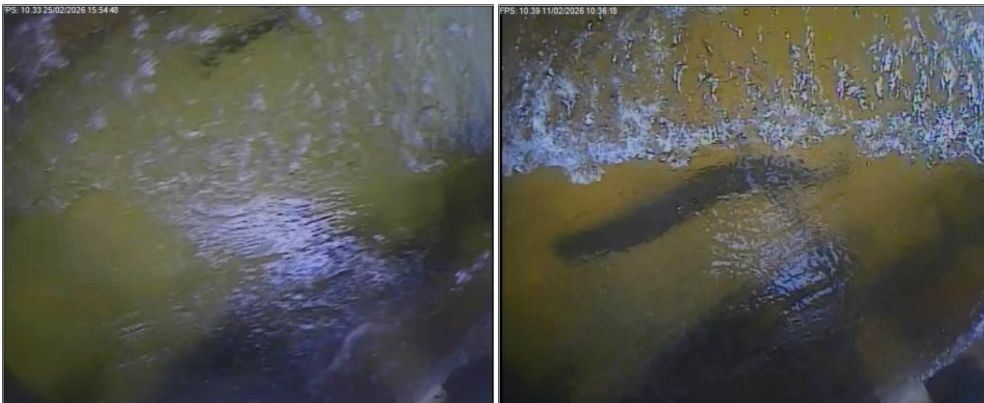
Figure 5 – A ~30 cm sea trout (left) moving up channel 20. The fish on the right made it halfway up the counter before turning around and heading back downstream. 25/02/26 (left) and 11/02/26 (right)

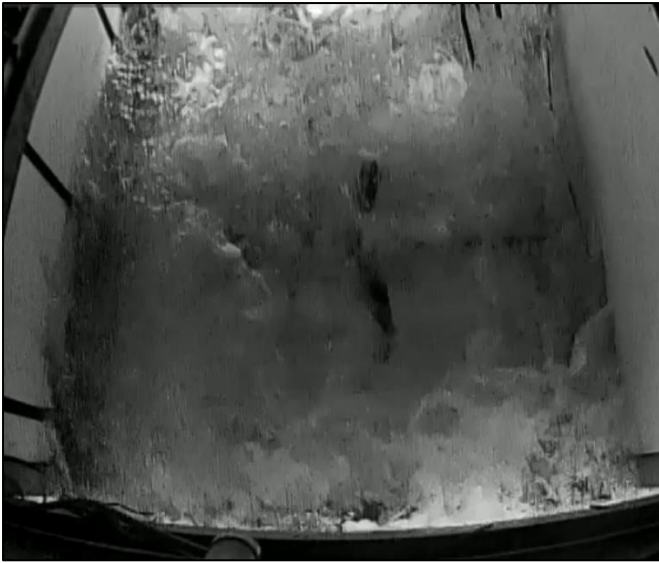
Figure 6 – A ~55 cm salmonid swimming up through the Turbine House rapids. The very high water levels created a waterfall over the frame of the fish pass entrance, adding to the turbulence and creating a challenge for the overhead camera. 12/02/26

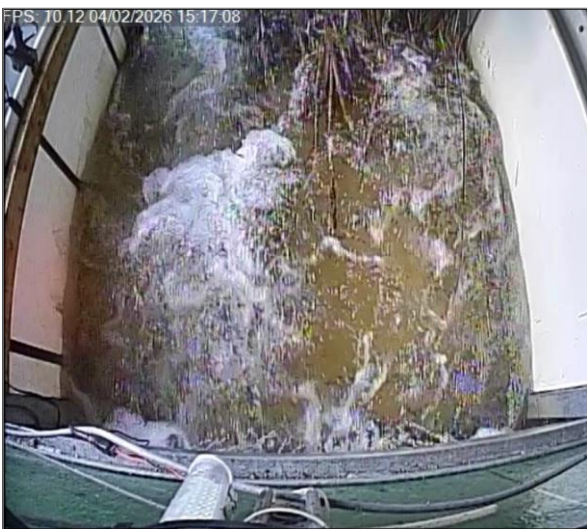
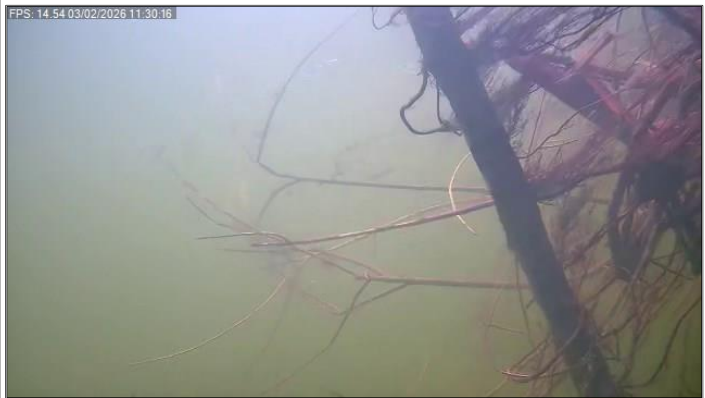
Figure 6 – A couple of particularly unsightly images from the first week of February at the Turbine House. A small tree and one large tree stump became wedged in the opening during the high flows, causing quite a bit of turbulence over the counter.

Earlier in February, the Turbine House fish pass was affected by a build-up of flood debris within the opening which created a lot of turbulence over the counter. Other than generating noisy signals within the counter, the data remained usable, and a fish was detected at this time moving upstream past a small tree that was wedged across its path.
